UNIVERSITY
OF MIAMI

DEPARTMENT of PSYCHOLOGY

SAFETY MANUAL

**University of Miami Department of Psychology
MRI Facility**

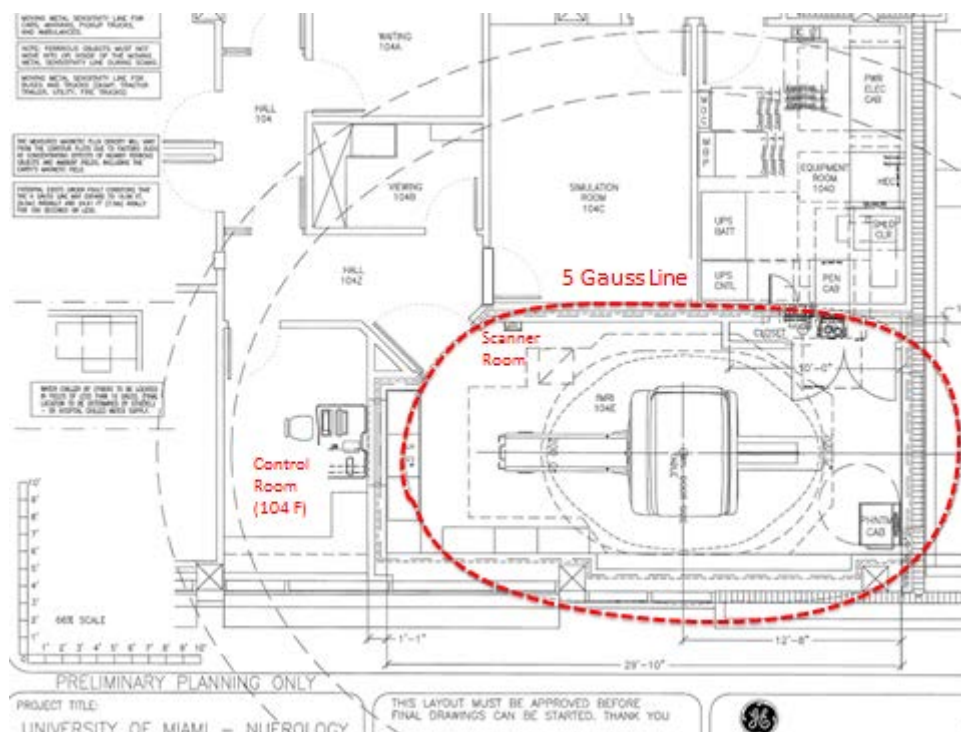
Figure 1. Diagram of the MR Suite with magnetic field lines. (The 5 Gauss line is indicated in red. This line specifies the perimeter around the MR scanner where the static magnetic field is Gauss or higher. Field strength of 5 Gauss and below is considered “safe” for the general public. Electronic devices and ferromagnetic objects are strictly prohibited inside the 5 gauss line.

It should be noted that the magnetic field is always present (i.e., magnets are always ON). Presence of high static magnetic fields call for extreme caution when working around MR magnets and special precaution are needed to ensure safety.

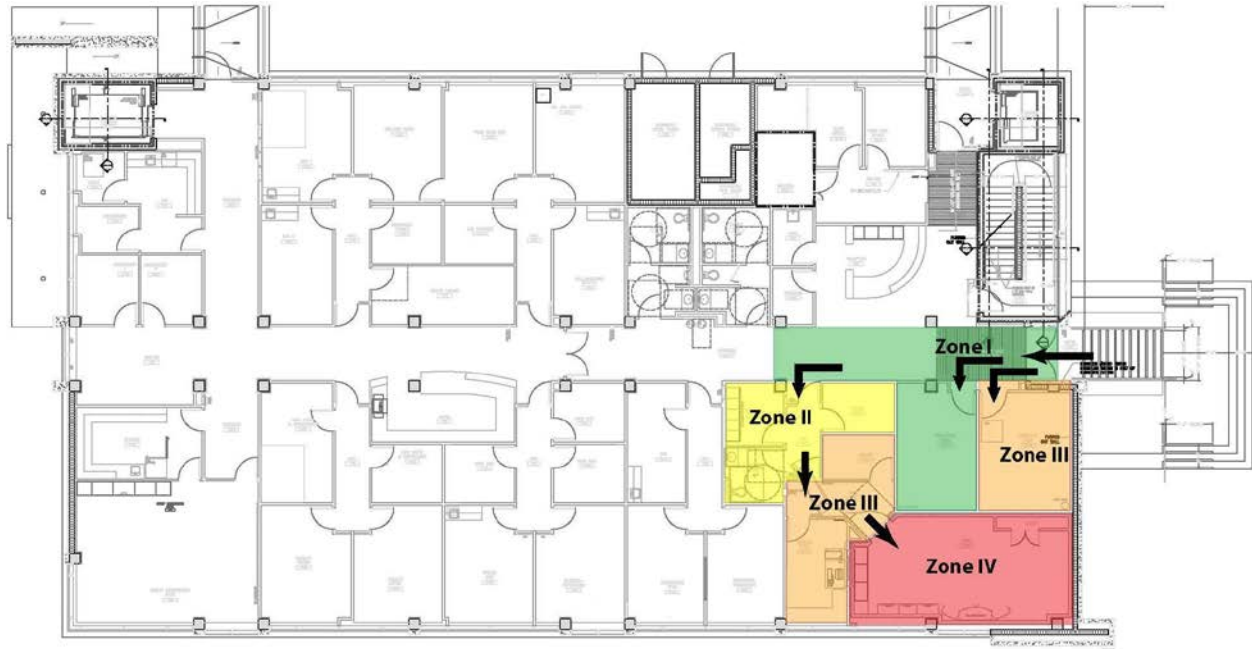
Figure 2. Diagram of the fMRI suite and zone designations.

The MRI suite houses a 3T MRI scanner; therefore, the ground floor has several zones that correspond to the safety levels associated with the 3T magnet. Entrance to the different zones is controlled to maintain a secure environment for research participants and staff.

Zone I is freely accessible by individuals working in the building. No special screening is required to be in Zone I.

Zone II is designated for pre-screening. Zone II includes two separate areas. One area is intended for simulation of the scanning procedures via mock scanner (Room 104C). The second area is intended for research participants reporting for research scans and consists of a waiting area, dressing room and restroom. Zone II is accessed from the reception/waiting area and is controlled by card reader access. Access is granted to personnel after completing the necessary safety training. All individuals participating in a research scan must complete a metal screening form and sign a pregnancy release form in Zone II before undergoing an MR scan.

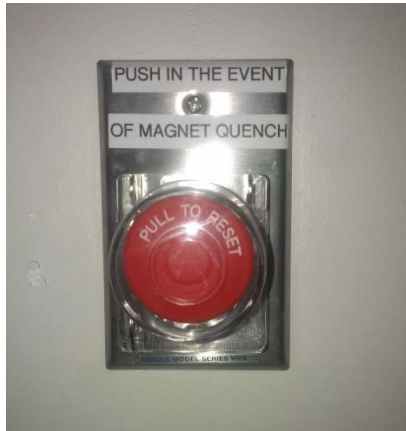
Figure 4. Quench button in the control room.

1. Use the intercom to alert the patient to stay calm and remain on the table until the operator gains access to the room to offer assistance.
2. Prop open the magnet room door to promote air circulation.
3. Transport the patient out of the room.
4. Evacuate all personnel from the area.
5. Inform the director and call the GE service engineer.

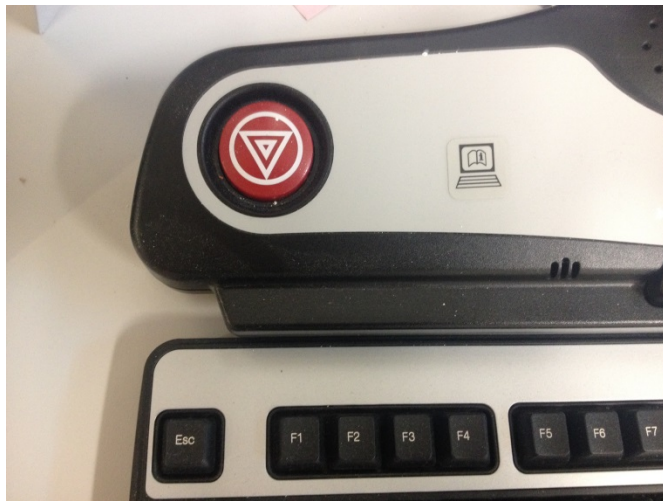
The **Emergency Off** button (pictured below) is on the operator's console, and there is also one in the scanner room. It removes ALL electrical power from the MRI console and the patient table, including any power sources from the Uninterrupted Power Supply (UPS) devices. The effect of pushing the Emergency Off button is to turn off the entire MR system EXCEPT for the static magnetic field and the magnet rundown unit (described below). This DOES NOT produce a quench.

Figure 5. Emergency Off Button in the control room.

The button should be used only to stop a scan during a patient emergency or during a serious equipment fault or hazard, such as fire or water in the vicinity of the MR equipment.
